Attention SP81610/SP85015

The SP81610/SP85015 (both petrol engines for BMW E46) are an obvious proof of this. Through the following images we will try to explain why.

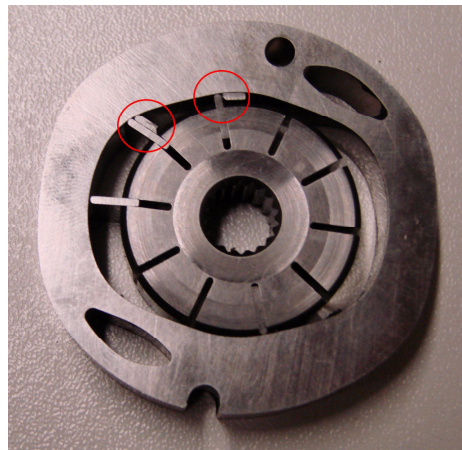
Figure 2

The rotor rotates in an oval chamber (figure 2), so that the vanes can move up and down in their seat. In a polluted system, the vanes can get blocked in their seat and / or break (circled in figure 2). In these cases the shaft breaks off (figure 3), because it remains driven as it is in direct connection with the engine.

It is recommended with these types of pumps (SP81610/SP85015) to flush very thoroughly, but also to use the magnetic filter (HF002) to intercept any future impurities.
