Attention SP81298/SP81302

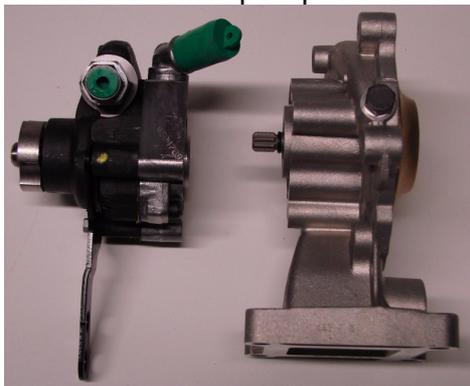
Figure 1

SP81298 (Ford Mondeo III 2.0 Diesel) and SP81302 (Ford Transit 2.0 Diesel) are connected through a toothed shaft on the rear of the steering pump (Figure 1). In many cases the water pump is the cause of the failure of the steering pump.

We recommend to replace also the water pump together with the steering pumps of the type SP81298/SP81302.

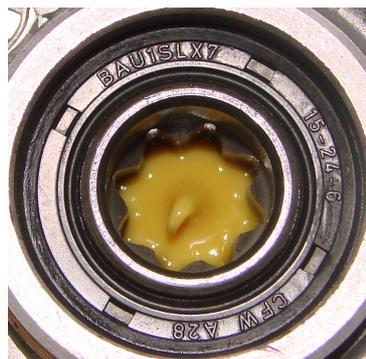
Figure 2 shows the connection on the back of the steering pump in which the toothed shaft of water pump sits. Play on the bearing of the water pump can damage the steering pump. Or if there is a leak at the pump, then water runs along the shaft of the steering pump and causes damage to the rear bearing of the steering pump.

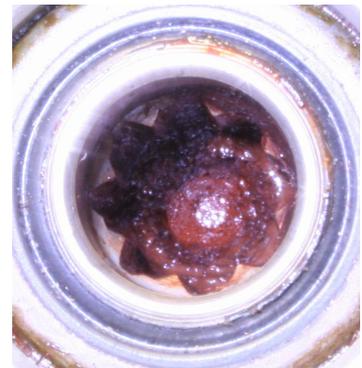
Figure 3

The teeth of the steering pump and / or water pump can be completely worn (Figure 3), which results in bad functioning of both pumps.
