Explanation of “*MORNING SICKNESS*”

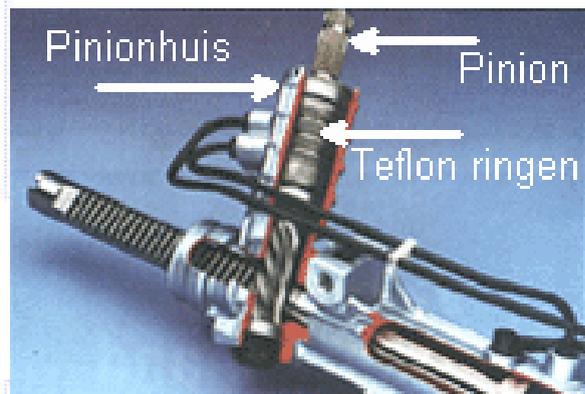
Within the rack and pinion system's control valve are Teflon ring seals which wear grooves in the pinion housing over the course of driving.

When the seals contract in cold weather and pull away from the grooved housing, a loss of assist in steering can result.

It is only when normal operating temperature is achieved that full power assist is regained. The Teflon rings have expanded and seal off the grooved areas in the pinion housing.

Steering racks affected, usually have an aluminium pinion housing. The hard Teflon makes grooves in the soft aluminium.

The pinion housing of a quality remanufactured steering rack is bored and sleeved. A hard metal sleeve prevents the Teflon rings from making grooves.

The problem is not only solved but the sleeve also makes sure “morning sickness” will not occur anymore.
