## Importance of the boots when fitting the rack

**Problem :** Quite often the steering rack starts to leak through the boots.

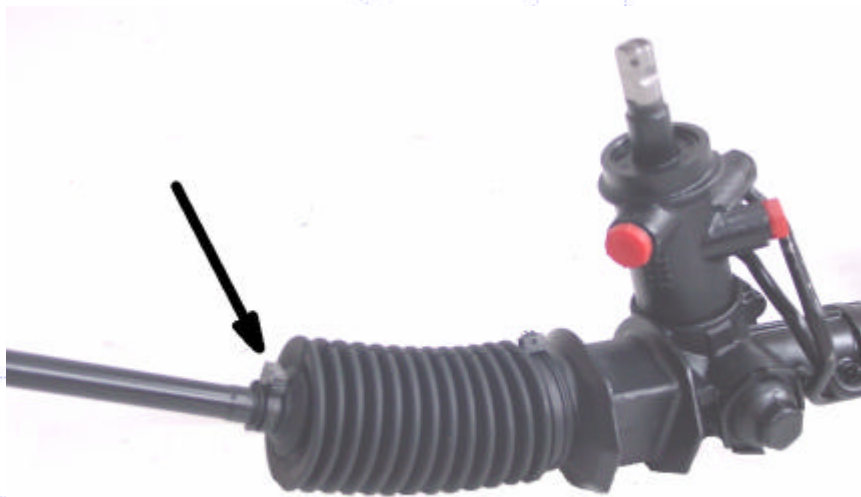
Besides not thoroughly flushing\* the most common cause of leakage is :

When mounting the tie rod ends and after the alignment of the wheels, the boots are not loosened.

Result : the boots get twisted and get torn after a period of time. This causes water and dirt to penetrate the boot and consequently to destroy the seals.

**Solution :** Always loosen the smaller clamp\*\* (see picture) on both sides of the rack. It is only after the alignment they should be tightened again. The boots are now perfectly in place again, without being twisted.

\*\*Until June 2006 plastic Ty-raps were used instead of the resealable clamps. In this case please replace the Ty-raps by new ones.
